Pre Completion Inspection

Plot 231 - The meadows

Friday 10 May 2024

Prepared For Mr & Mrs Brampton

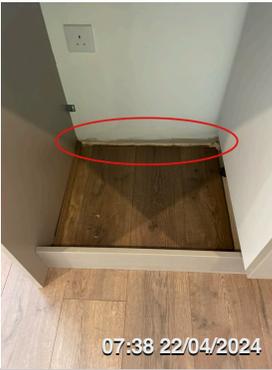
Kitchen
No Skirting Installed
Joinery contractor

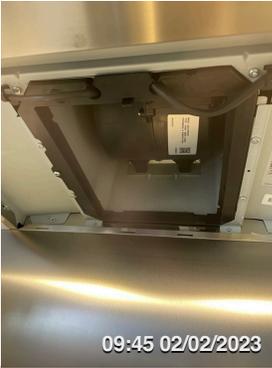
Kitchen
Extractor Fan Missing Internal Cover
Appliance fitter

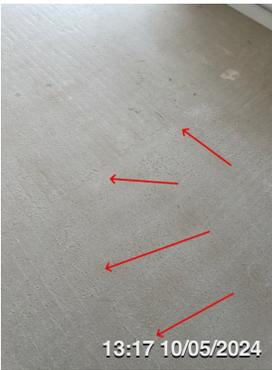
Kitchen
Poor Surface Finish
Floor contractor

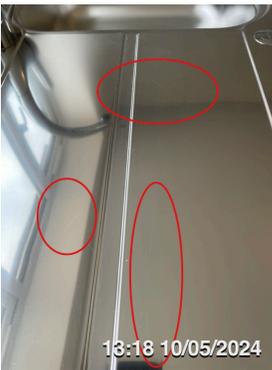
Kitchen
Multiple Marks Visible On The Sink And Drainer
Kitchen supplier

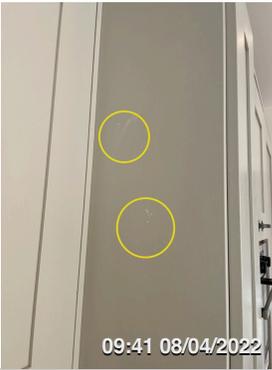
Marks To Kitchen Panels

Kitchen supplier

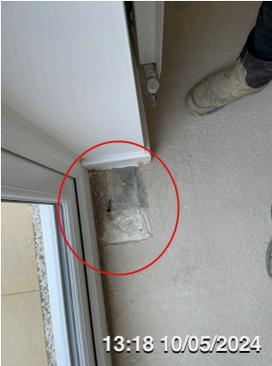
Kitchen

Floor Damaged

Groundwork's contractor

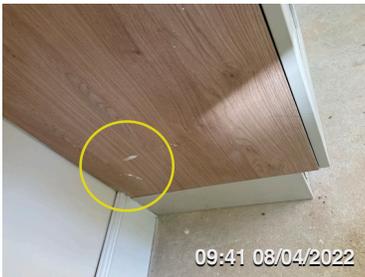
Paint Marks On Kitchen Units

Cleaning contractor

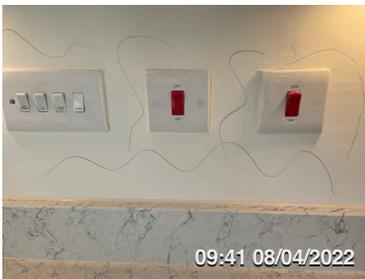
Kitchen

Poor Finish Around Sockets

NHBC 9.1 Paint & decorating contractor

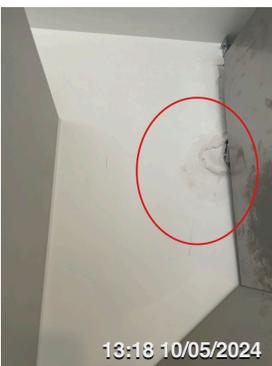
Kitchen

Make Good Around Extractor Hood

Patcher

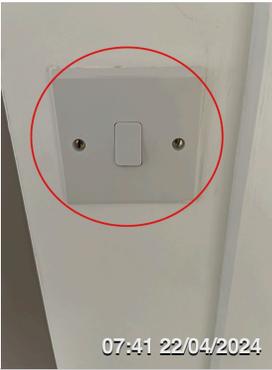
Room

Sockets Not Level & Missing Covers
Electrical contractor

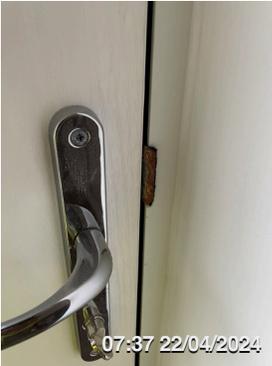
Front Door

Out Of Square 2+3mm
Front door manufacturer

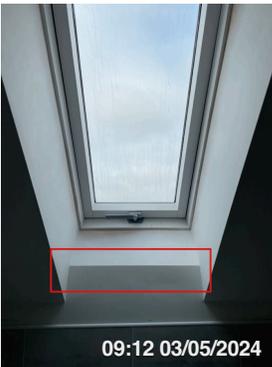
Main Bedroom

Plasterboard Not Trim Not Level
Plasterer

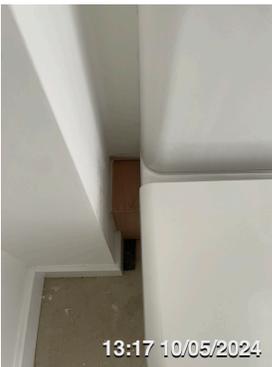
Cloakroom

Pipe Boxing Not Decorated
Paint & decorating contractor

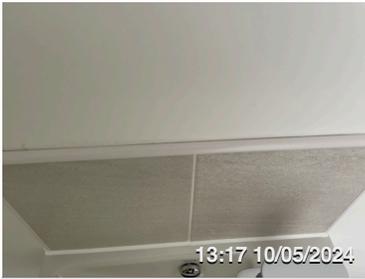
Cloak Room

No Sealant Around Tile Trim

Sealant contractor

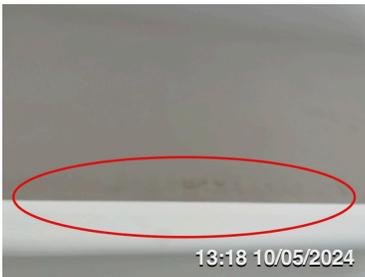
Living Room

Damp Showing Through Plasterboard Trim

Plastering contractor

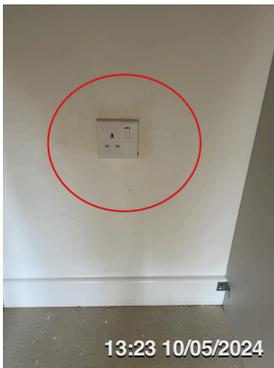
Utility

Poor Paint Finish

Painter & decorating contractor

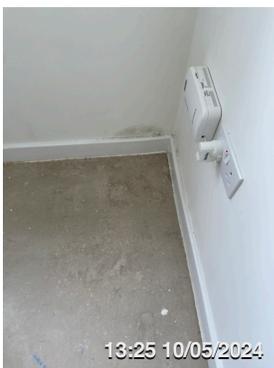
Living Room

Mould Visible In Multiple Rooms

Painting & decorating contractor

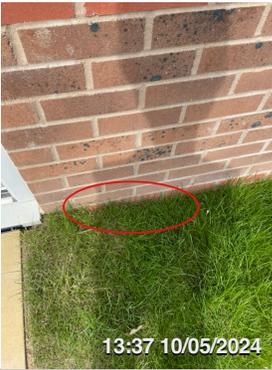
Brickwork

Inadequate Airbrick Clearance
 NHBC technical guidance 6.1/27
 Brickpatcher

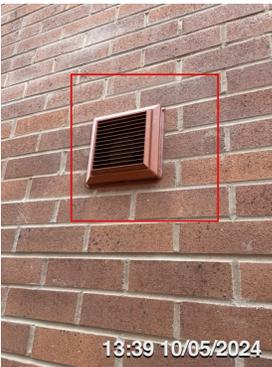
Building

Extractor Fan Leaking Internally With A Failed Seal
 Sealant contractor please refer to document below

9.1.9 Joint sealants

Joint sealants shall have a neat and tidy appearance.

Sealants should be tooled to:

- remove blisters and irregularities
- achieve a compact, smooth neat surface finish.

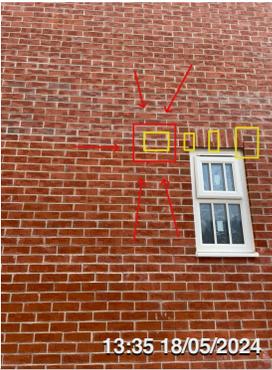
Building

Weep Vents Missing

NHBC standard 6.1.17 weepholes should be provided at a maximum of 450mm

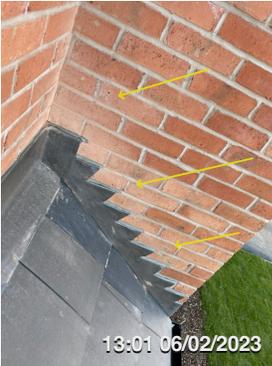
Brick Work Verge

Clean Brickwork

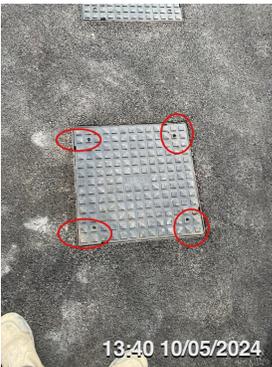
Driveway

Inspection Lids Missing Screws

Ground works contractor

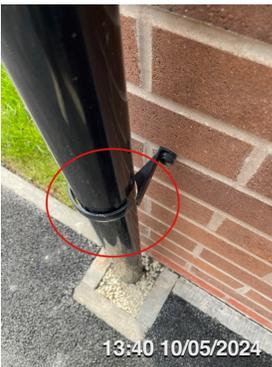
Downpipes

Damaged Clip To Left Hand Side Downpipe

Plumbing contractor

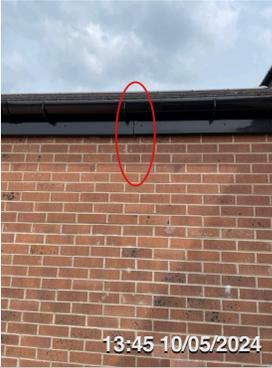
Fascia

Joint Clip Missing
Joinery contractor

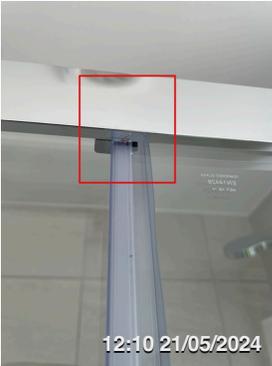
Ensuite

Visible Damaged To Shower Door
Plumbing contractor

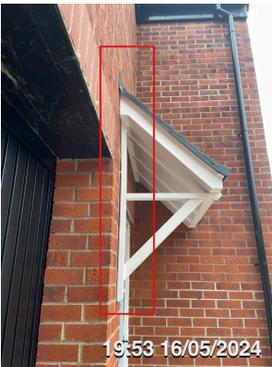
Building

Brickwork Not Level & Out If Tolerance
NHBC standards 9.1.2
8mm tolerance of a 25mm spacing block

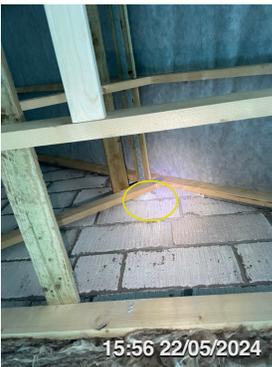
Internal Blockwork

Gable Restraint Installed On A Cross Joint
Nhbc 7.2.8 restraint straps must be installed behind a full block

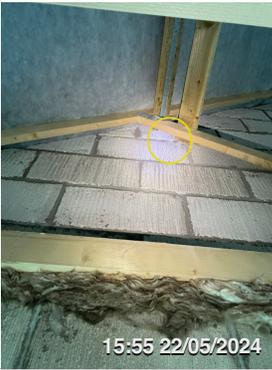
Internal Blockwork

Gable Restraint Installed On A Cross Joint

Nhbc 7.2.8 restraint straps must be installed behind a full block

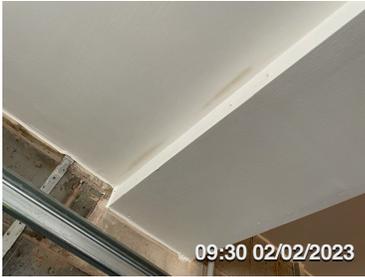
Garage

Poor Paintwork Finish

Paint & decorating contractor

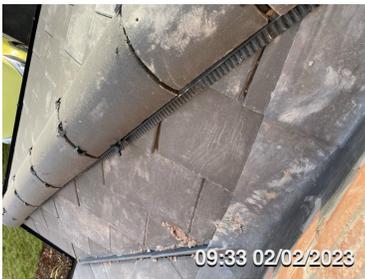
Low Level Roof

Mortar Stains & Rubble Left On Roof Verge

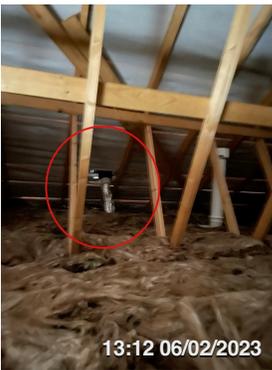
Loft

Tile Vent Ducting Nit Mechanically Fixed
