# NEW HOME SNAGGING REPORT

TYPE OF PROPERTY	DETACHED
BUILD TYPE	TRADITIONAL
DEVELOPER	MY BUILDER HOMES
YEAR BUILT	2024
WARRANTY PROVIDER	NHBC
WEATHER CONDITIONS	DRY
TYPE OF INSPECTION	POST COMPLETION SNAGGING REPORT
MAINS SERVICES	ON
GARAGE	DETACHED SINGLE
NUMBER OF FLOORS	2
CAVITY WALL INSULATION	BLOWN INSULATION

CLIENT	SAMPLE
ADDRESS	SAMPLE ADDRESS
SURVEYORS DETAILS	ELIAS SHAW BSC (HONS) ,TECHRPSA , NCC
INSPECTION DATE	26TH OCTOBER

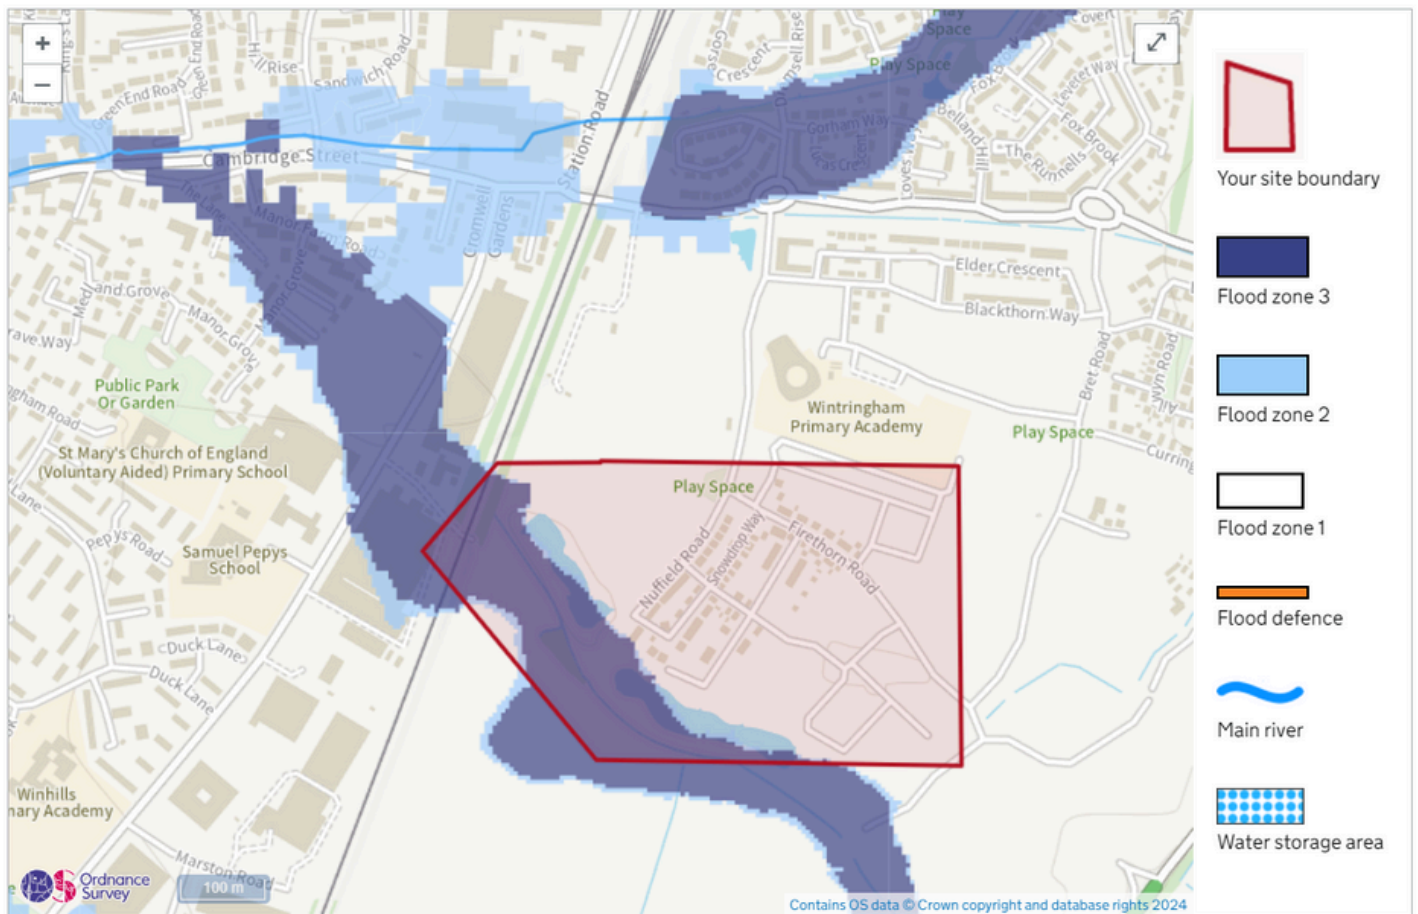
# FLOOD PLAN

This flood risk map shows that parts of your site fall within moderate (Flood Zone 2) and high-risk (Flood Zone 3) flood areas, mainly along the western and southern edges. This means these areas are more likely to experience flooding. The rest of the site has a low risk. Consider flood protection measures for the higher-risk zones.

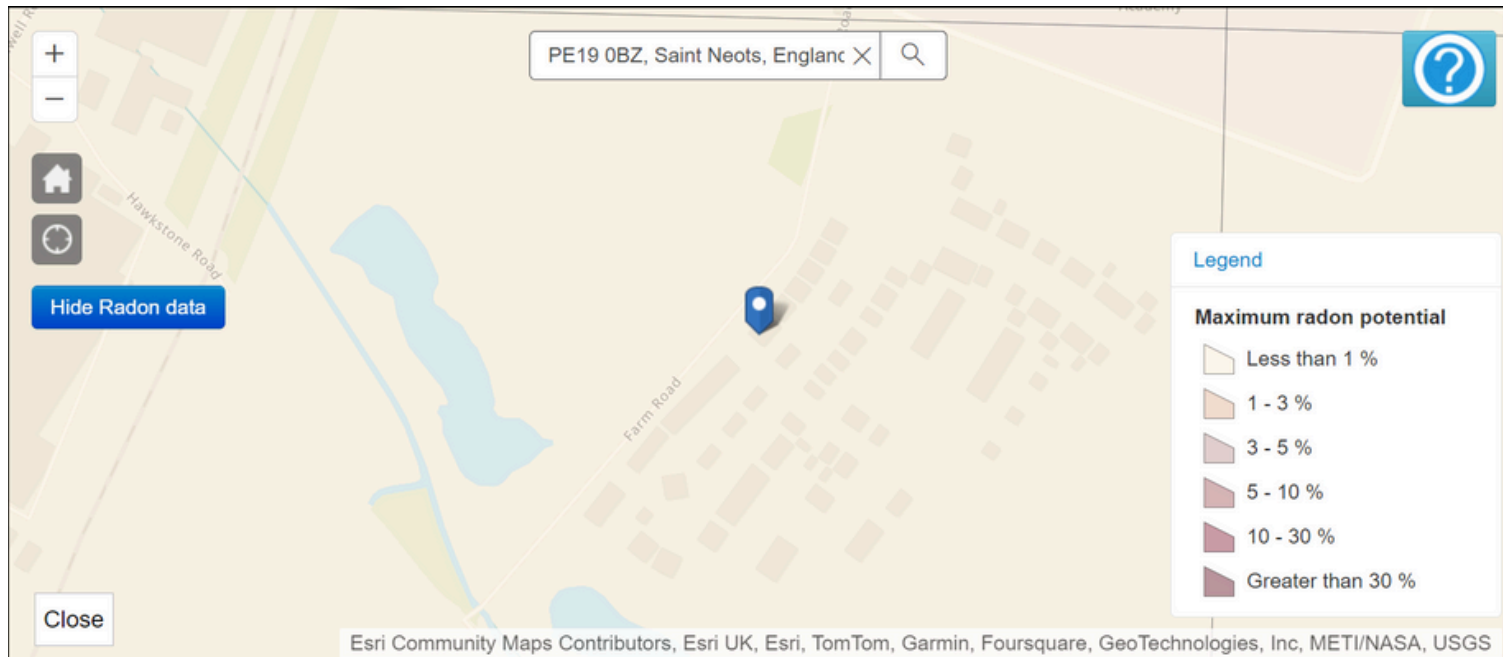
# RADON MAP

Maximum Radon Potential: The site falls within the less than 1% radon potential category, which represents the lowest risk level.

**Summary:** With a radon potential of less than 1%, the risk of radon gas presence is minimal for this area. While specific radon mitigation measures are likely unnecessary, adherence to general radon safety guidelines is still advisable.

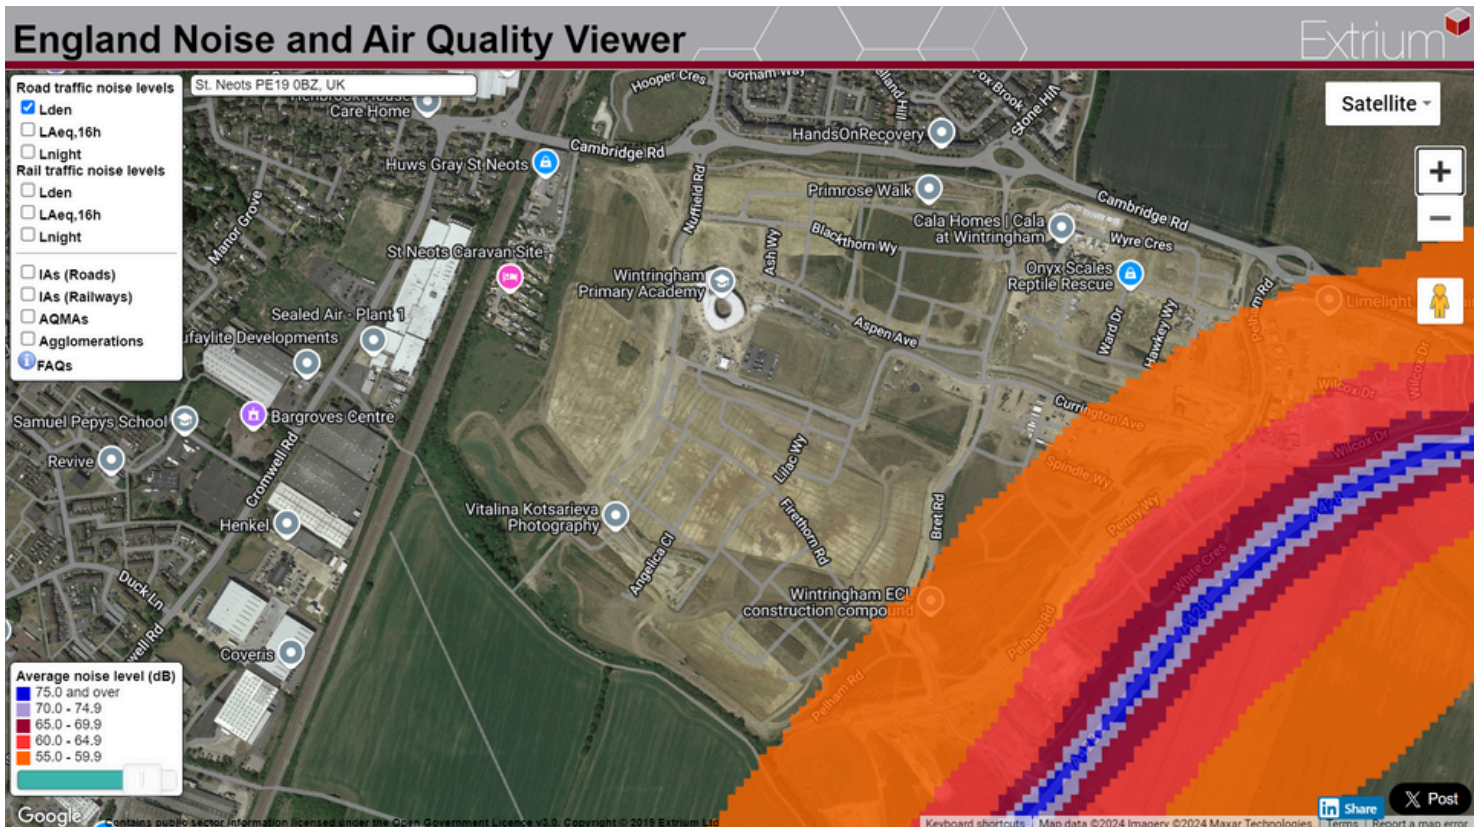
# NOISE LEVEL & AIR QUALITY REPORT

- Average Noise Levels: The eastern part of the site is affected by elevated noise levels, with average levels reaching up to 75 dB in certain areas, indicated by the orange and red zones on the map.
- These levels correspond to higher traffic noise exposure, which could affect outdoor and indoor comfort in those parts of the site.

**Summary:** Noise levels vary across the site, with the eastern section experiencing higher average noise levels due to nearby traffic. It may be beneficial to consider sound insulation or noise mitigation measures for buildings located in these higher-exposure areas.

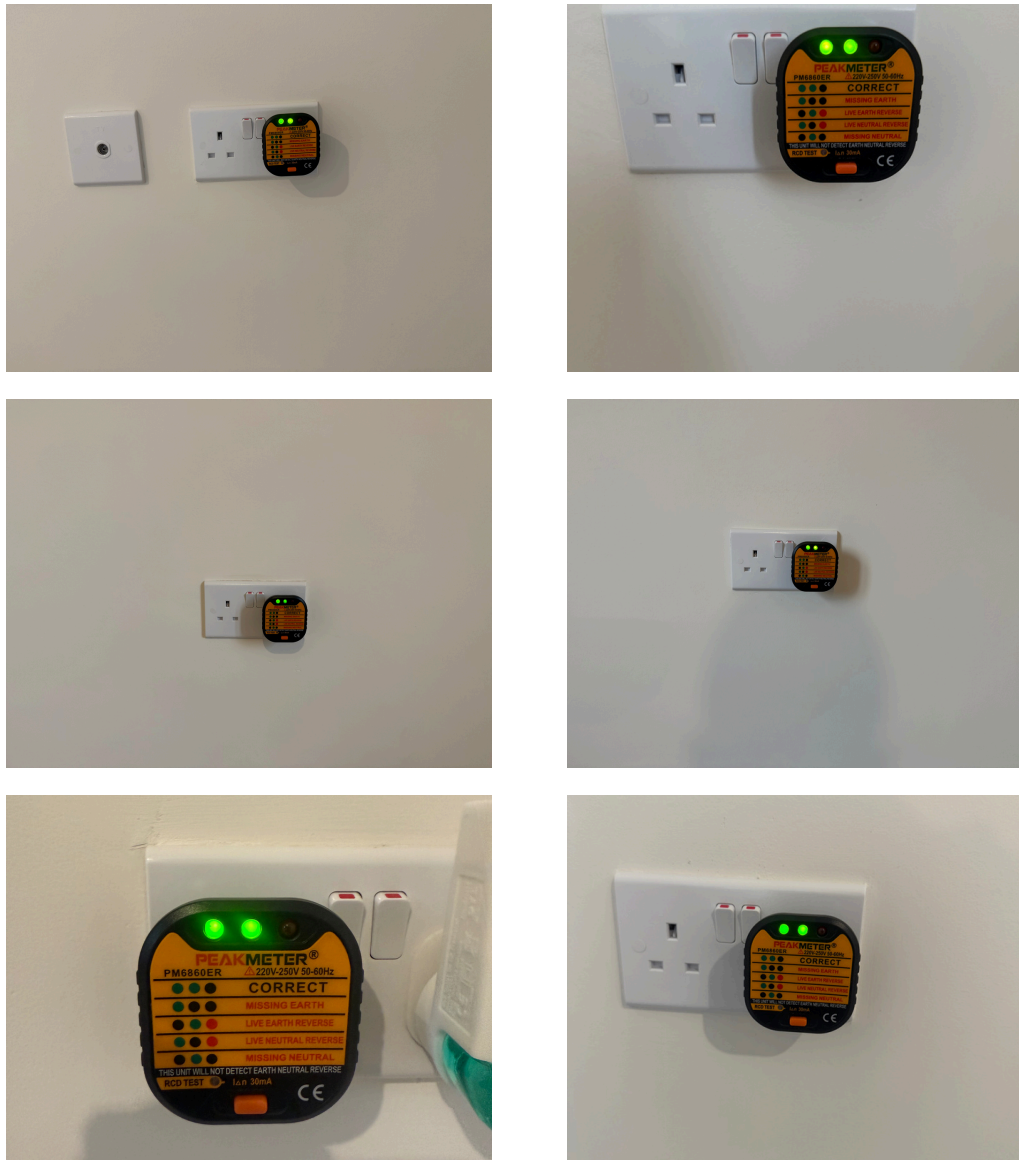
# SOCKET TESTING

During the inspection all the sockets inside the property were  
tested  
no issues where highlighted
