Copy of "Home Snagging Survey"

Friday 4 October 2024

66 Actions To Meet Required Standard

New Homes Inspections

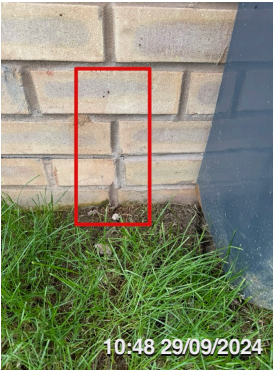
Straight Joint Brickwork

Poor brick work appearance straight joints on fair faced masonry

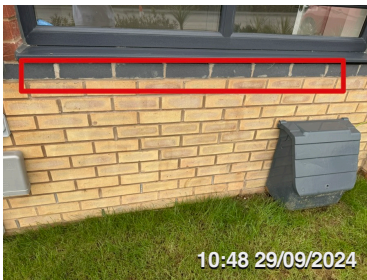
Brick Clean

Appearance of brickwork is visibly dirty with multiple mortar stains on facing bricks

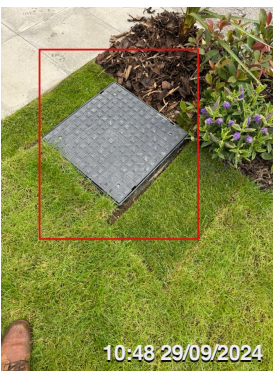
Inspection Cover

Inspection chamber lid is not flush with garden landscaping

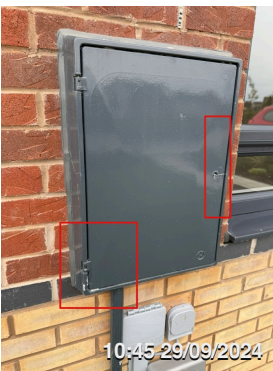
Meter Box Marks

Electric meter box is marked, paint primer is visible

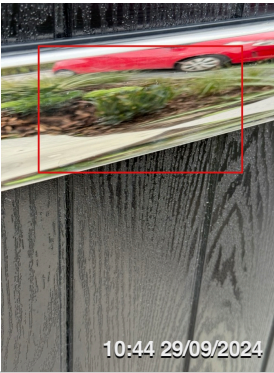
Marks On The Letter Box

Letter box has multiple marks on scratches visible

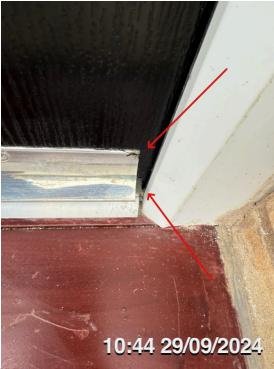
Weather Bar End Cap

Weather bar end cap is missing on the right hand side

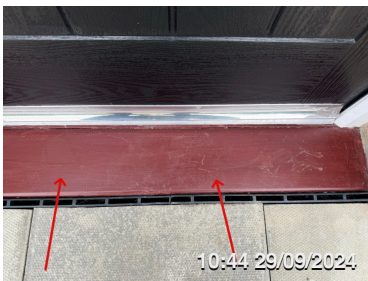
Front Door Threshold Sill

Front door threshold sill has multiple marks and damages

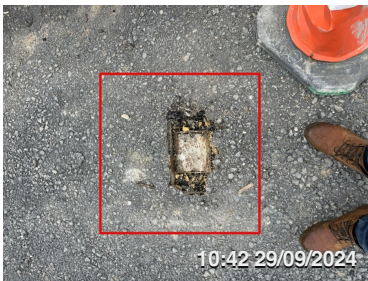
Water Meter

Water meter set to low please raise in line with pathway remedial works

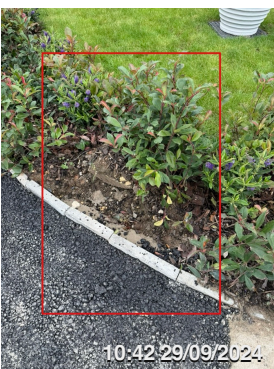
Planting

Plants had been removed and un settled near pathway

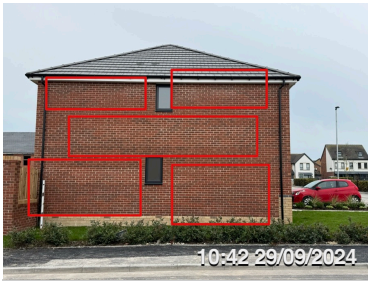
Mortar Colour Variation

Areas of colour variations on mortar should be minimised - visually mortar had set a different colour

NHBC chapter 7.1 finishes

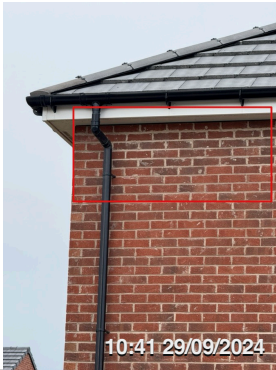
Cleaning And Maintenance

Fair faced masonry should be clean with no mortar smears visible

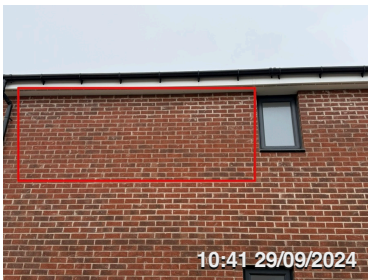
Cleaning And Maintenance

Fair faced masonry should be clean with no mortar smears visible

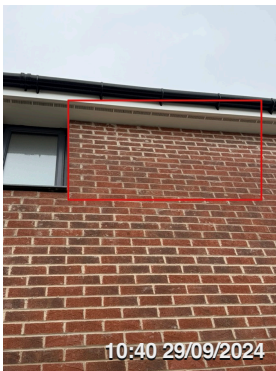
Cleaning And Maintenance

Fair faced masonry should be clean with no mortar smears visible

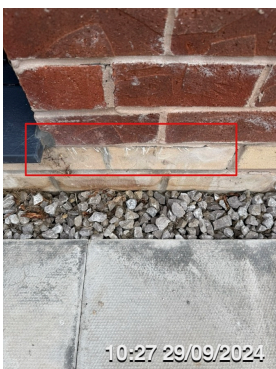
Cleaning And Maintenance Patio Door

Fair faced masonry should be clean with no mortar smears visible

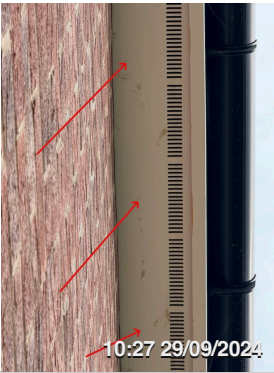
Cleaning And Maintenance

Fascia and soffit board was visibly dirty at the time of the inspection

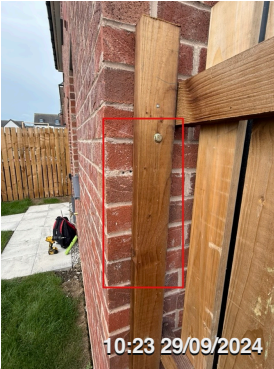
Mortar Holes

Mortar has screw hole marks visible please fill

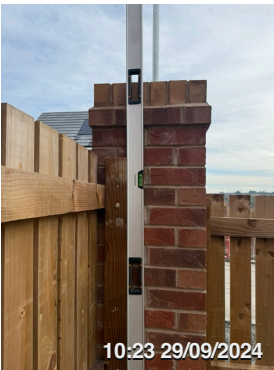
Fencing Not Plumb

Fence panel nearest to the rear gable was out of plumb

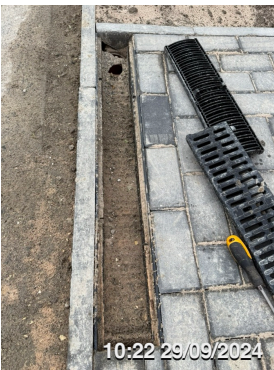
Maintenance & Cleaning

Aco drain was fully of sand and other spoil please empty to ensure surface water passes freely

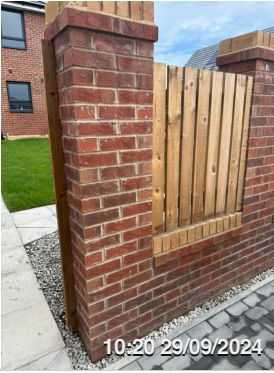
Cleaning And Maintenance

Fair faced masonry should be clean with no mortar smears visible

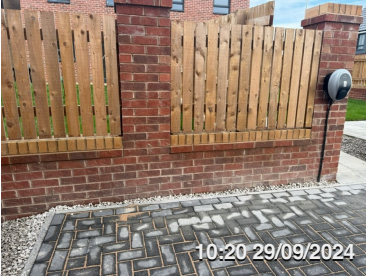
Cleaning And Maintenance

Fair faced masonry should be clean with no mortar smears visible

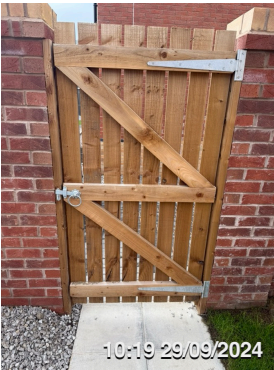
No Lock Fitted To The Rear Gate

Of the gate leads to a main road or accessible public footpath a secure locking mechanism is recommended

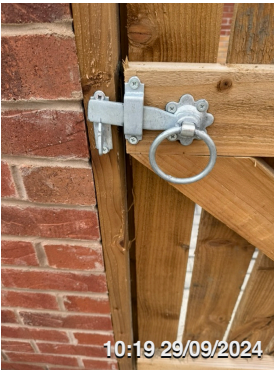
Gate Latch Not Operational

At the time of inspection the rear garden gate latch was not sitting in the keep

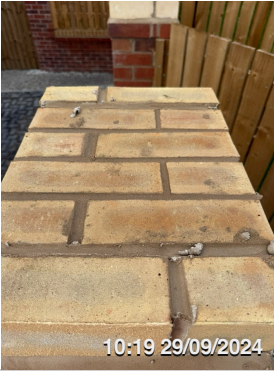
Cleaning And Maintenance

Fair faced masonry should be clean with no mortar smears visible

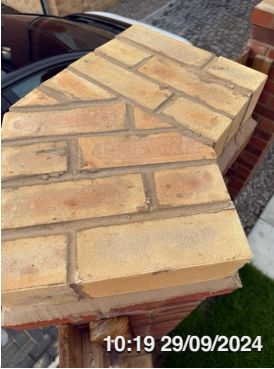
Cleaning And Maintenance

Fair faced masonry should be clean with no mortar smears visible

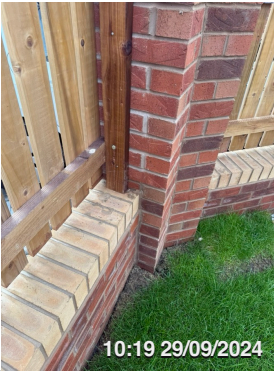
Cleaning And Maintenance

Fair faced masonry should be clean with no mortar smears visible

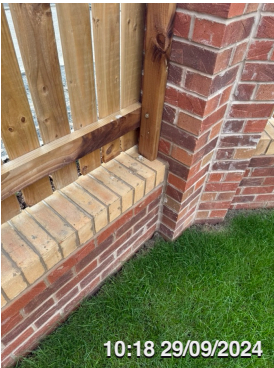
Cleaning And Maintenance

Fair faced masonry should be clean with no mortar smears visible

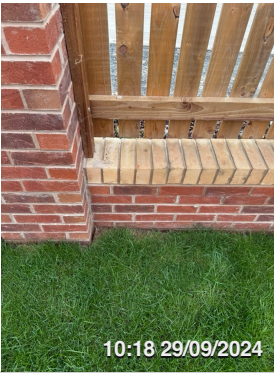
Cleaning And Maintenance

Fair faced masonry should be clean with no mortar smears visible

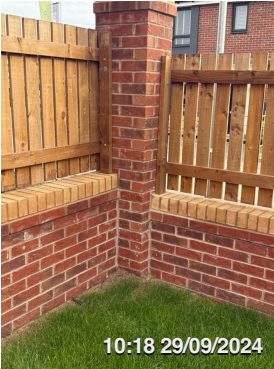
Cleaning And Maintenance

Fair faced masonry should be clean with no mortar smears visible

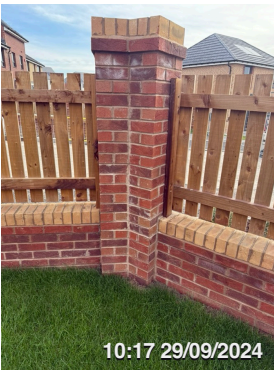
Cleaning And Maintenance

Fair faced masonry should be clean with no mortar smears visible

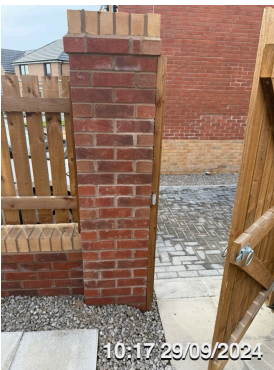
Cleaning And Maintenance

Fair faced masonry should be clean with no mortar smears visible

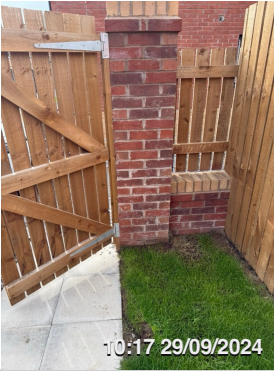
Cleaning And Maintenance

Fair faced masonry should be clean with no mortar smears visible

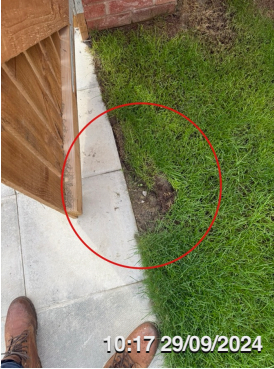
Gate Catching On The Turf

The bottom of the gate was catching on the turf causing a tear

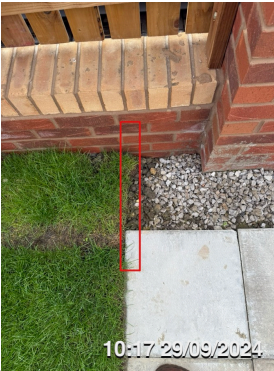
Edgings Missing

No edging strip between hard & soft landscaping

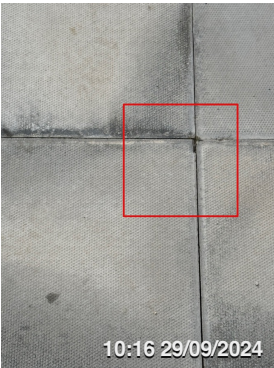
Chips To Slabs

X2 slabs inspected had large chips taken out of the corners

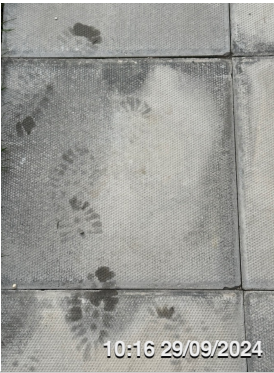
Chips To Slabs

X2 slabs inspected had large chips taken out of the corners

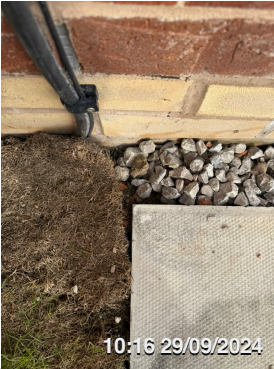
Edgings Missing

No edging strip between hard & soft landscaping

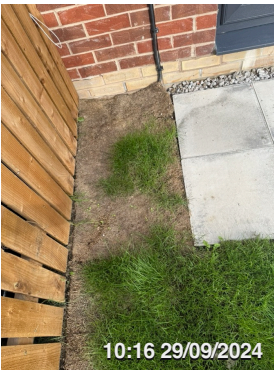
Dead Turf

Turf was visibly dead in multiple areas of the rear garden

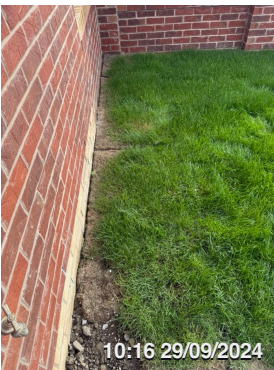
Dead Turf

Turf was visibly dead in multiple areas of the rear garden

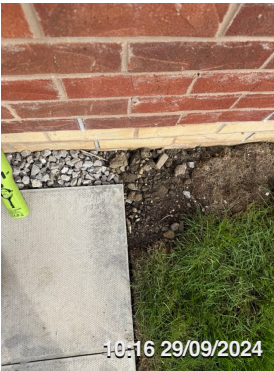
Dead Turf

Turf was visibly dead in multiple areas of the rear garden

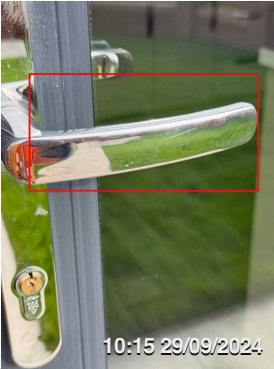
Handle Marked

Rear door handles marked and scratched

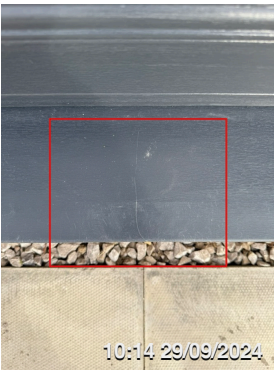
Patio Door Sill Marked

Rear patio door sill was marked and scratched

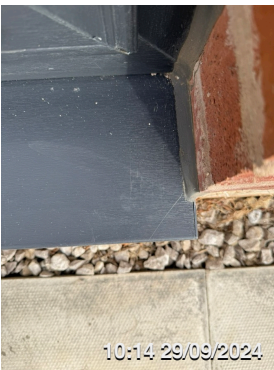
Patio Door Sill Marked

Rear patio door sill was marked and scratched

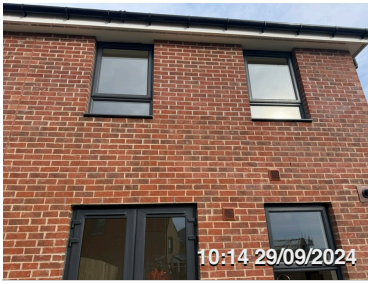
Cleaning And Maintenance

Fair faced masonry should be clean with no mortar smears visible

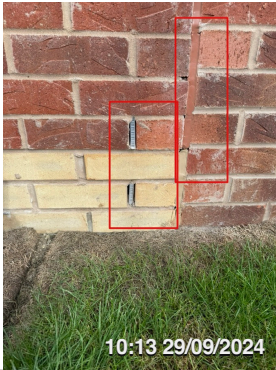
Mortar Joints

Multiple mortar joints where not consistently filled

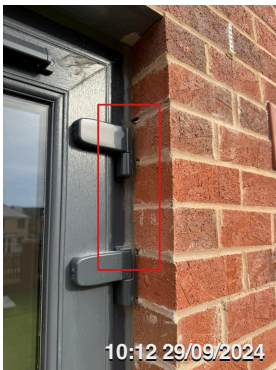
Mortar Joints

Multiple mortar joints where not consistently filled

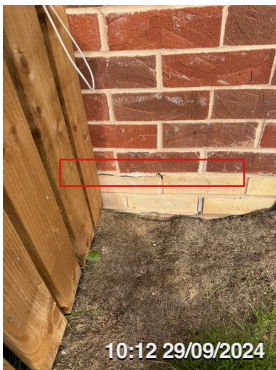
Mortar Joints

Multiple mortar joints where not consistently filled

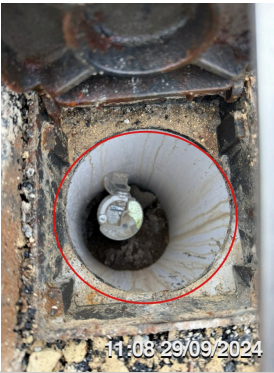
Water Meter

No frost cap fitted to water meter

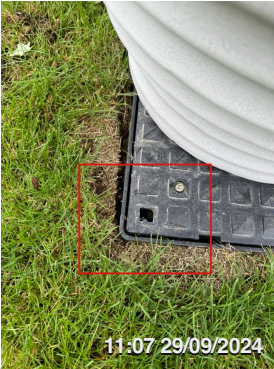
Inspection Lid

Inspection cover lid damaged

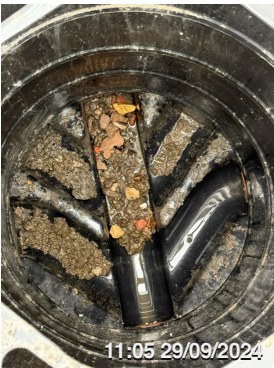
Drainage had debris and loose material at the bottom please clear to enable clear flow of waste

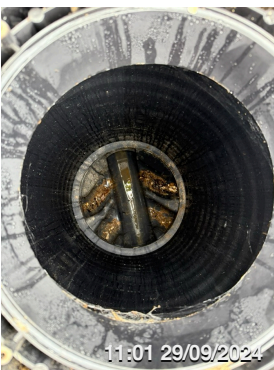
Rubble In The Inspection Chamber

Drainage had debris and loose material at the bottom please clear to enable clear flow of waste

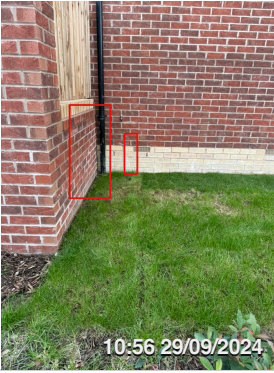
Cleaning And Maintenance

Fair faced masonry should be clean with no mortar smears visible

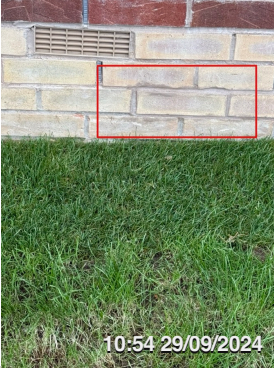
Cleaning And Maintenance

Fair faced masonry should be clean with no mortar smears visible

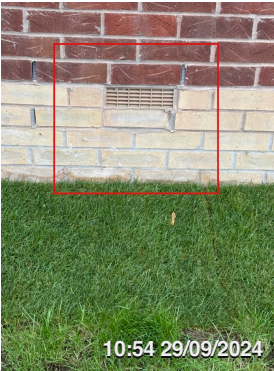
Cleaning And Maintenance

Fair faced masonry should be clean with no mortar smears visible

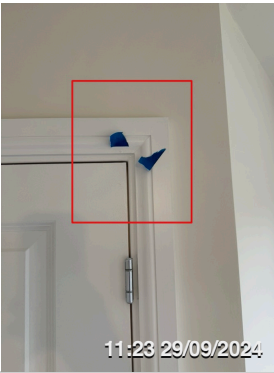
Paint Touch Ups & Nail Pins

Paint work should be even smooth and consistent ,with no visible defects

NHBC 9.3 internal finishes

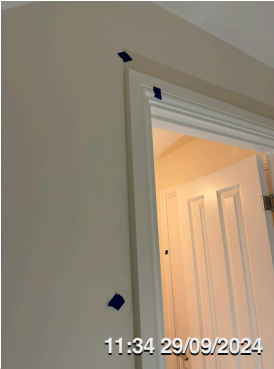
Paint Touch Ups & Nail Pins

Paint work should be even smooth and consistent ,with no visible defects

NHBC 9.3 internal finishes

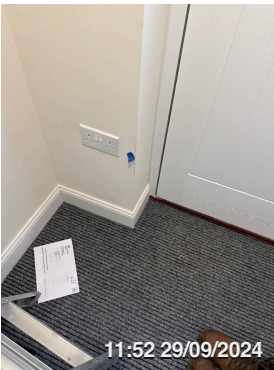
Paint Touch Up

Paint work should be even smooth and consistent ,with no visible defects

NHBC 9.3 internal finishes

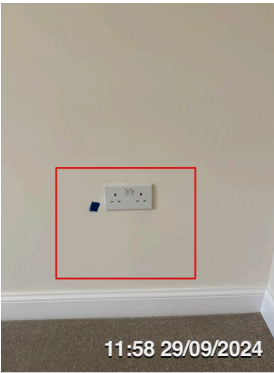
Paint Touch Ups

Paint work should be even smooth and consistent ,with no visible defects

NHBC 9.3 internal finishes

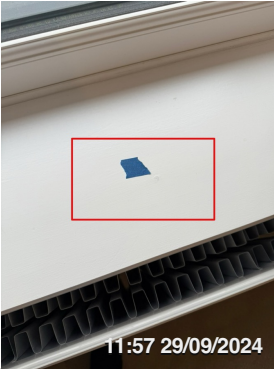
Paint Touch Ups

Paint work should be even smooth and consistent ,with no visible defects

NHBC 9.3 internal finishes

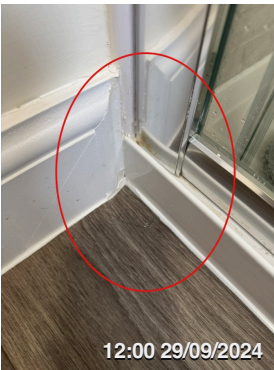
Leak

Shower door was leaking when wet tested

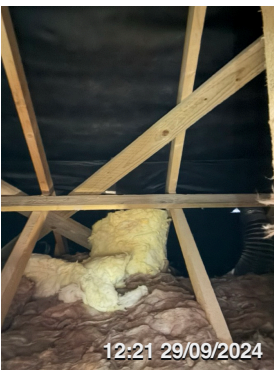
Housekeeping

Rock-wool insulation left in the roof space

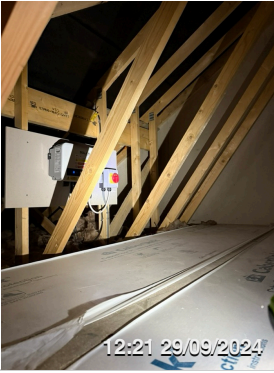
Smoke Detector And Light

BS - 5839 - 6

NHBC standard 8.1.6.12 No smoke detector installed in the roof space requirement for part L , also adequate lighting ie bulb should be installed
